LANDSLIDE SUSCEPTIBILITY IN THE WILLIAMSPORT 1- BY 2-DEGREE QUADRANGLE, PENNSYLVANIA

Environmental Geology Report 9

by Helen L. Delano and J. Peter Wilshusen
Bureau of Topographic and Geologic Survey

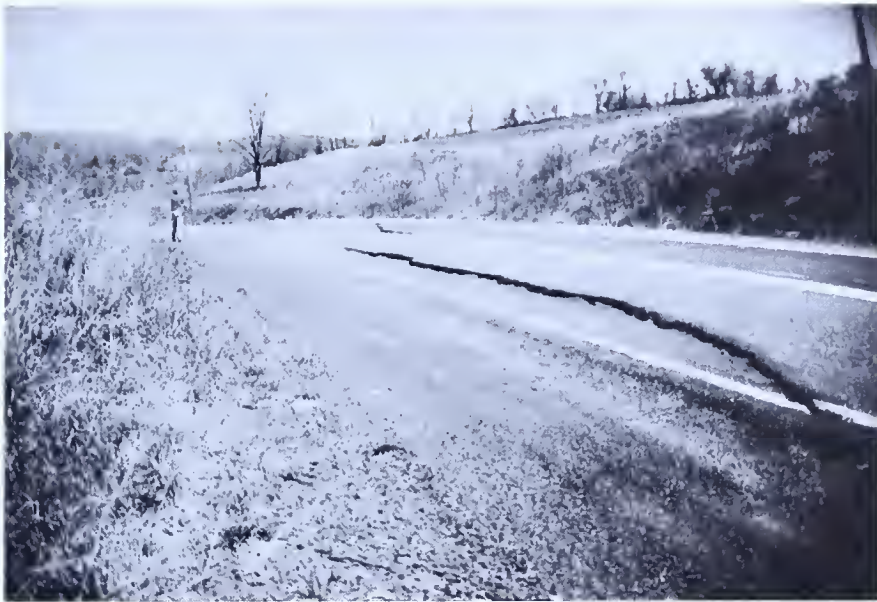
Figure 55. The head scarp and associated pavement disruption of the Mansfield slide along Pa. Route 660.

15 (Figure 53). The slide area is a complex of active, recent, and older slumps and earthflows. Most of the toe of the slide is along the stream bank and therefore is subject to ongoing erosion. The head of one of the most active areas of slumping causes continual disturbance of Pa. Route 660 (Figures 54 and 55). Repeated repairs to the pavement and shoulder have obscured evidence of the total displacement at the head scarp.

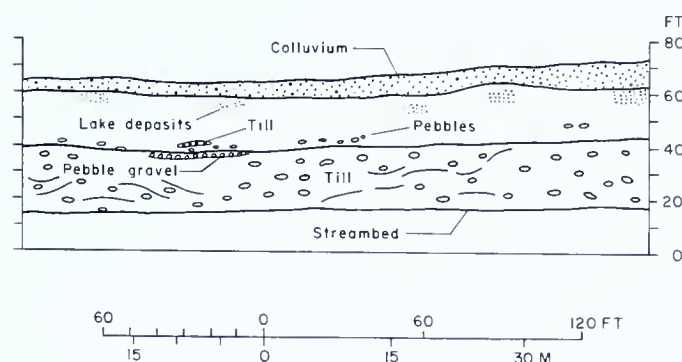
Figure 56. Sketch of an exposed section of till, lake deposits, and colluvium at the southeast end of the Mansfield slide (from Denny and Lyford, 1963, Figure 10-E, p. 16).

At the southeast end of the slide area is a spectacular exposure of till overlain by glaciolacustrine clay and colluvium. The site was measured and described by Denny and Lyford (1963) (Figure 56). Figure 57 is a photograph of the same area. This bare scar is apparently maintained by shallow translational sliding of material as it weathers from the approximately 45-degree (100-percent) slope. Because the stream at the toe removes the slide material, there can be only speculation on the earlier shape and original failure mechanism of this part of the slope. The northern portion of the slide is a typical large slump-earthflow having minor active scarps and flow lobes in the body of the slide and very wet, muddy flow lobes at the toe (Figure 54). The main scarp is subdued and well covered with grass and brush. The whole slide mass is somewhat wet, but the only standing water observed was in the area just below the pavement patching. The slide appears to involve only surficial material. The glacial deposits are in contact with shaly siltstone of the De-

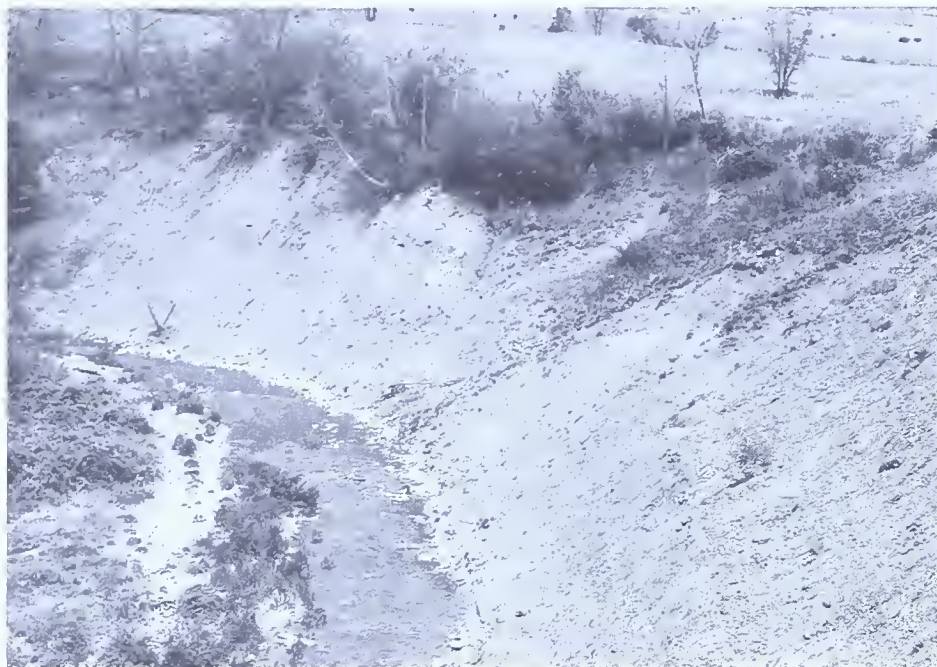
Figure 57. Photograph of the section shown in Figure 56.

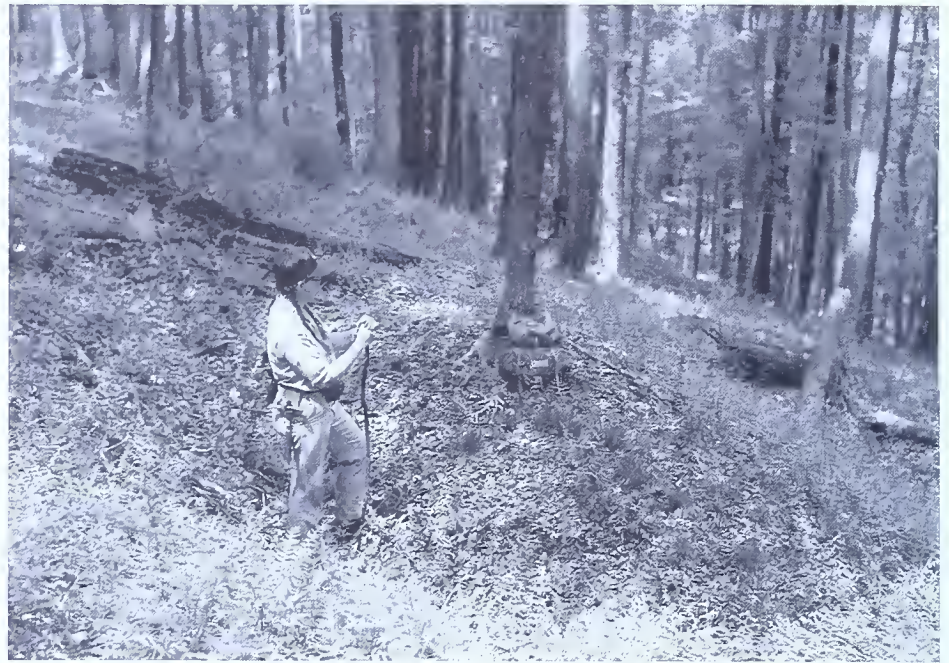
Figure 60. An example of "tree-throw topography" on the Conrad slide. The person is standing in a pit left when a tree toppled and tore up a large mass of soil attached to the roots. As the soil was washed from the roots and the tree decayed, the mound of soil under the backpack and younger tree (center) was left behind.

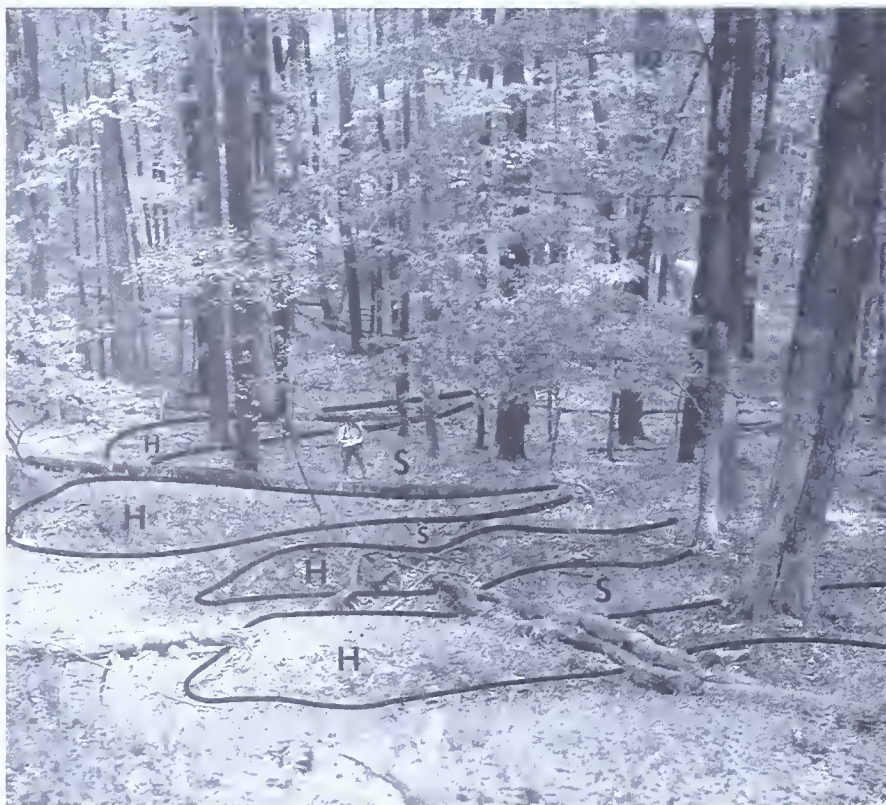
Figure 61. View downslope near the center of the Conrad slide deposit showing hummocky topography (H, hummock; S, swale).

The surface of the debris-flow deposit is also marked by larger scale "hummocky topography," which is typical of landslide areas (Figure 61). The toe of the old slide deposit is adjacent to the flat, swampy valley floor of Wild Boy Run (Figure 62). The toe at present appears to be the partly eroded and dissected remains of lobes that flowed out onto the flat floor of the valley. The upper surfaces of these flow lobes range from about 5 to 30 feet above the swamp at the toe.

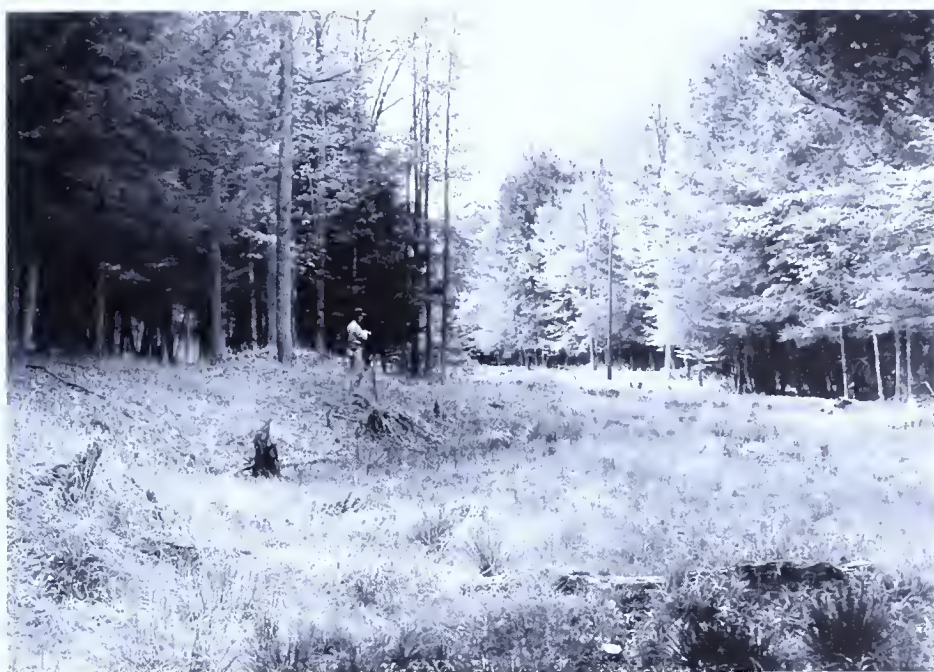
Figure 62. The toe of the Conrad slide deposit (on the left) and the valley floor along Wild Boy Run.

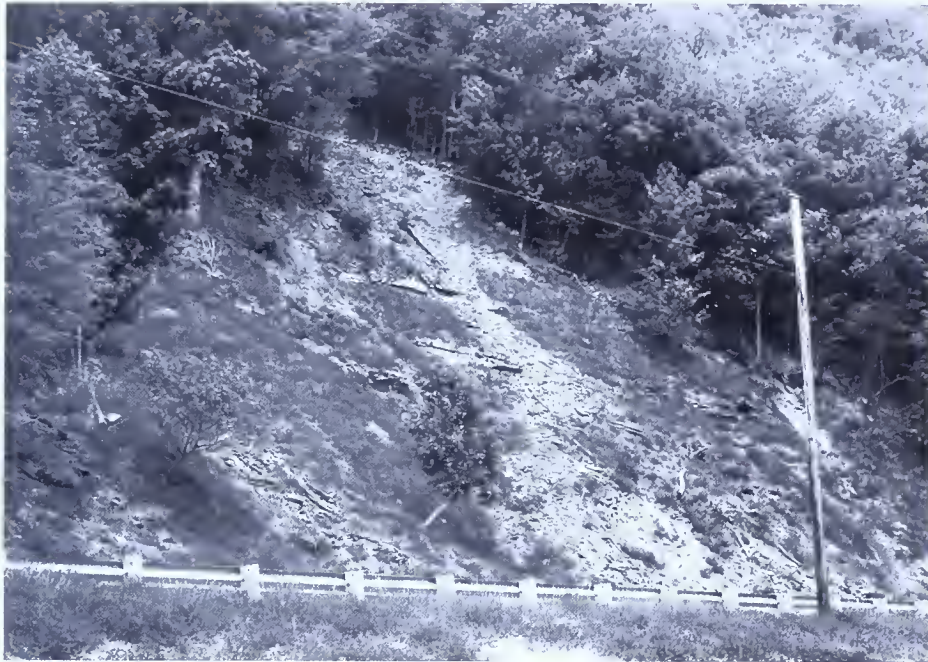
Figure 65. Photograph of the Kettle Creek slide from across the road.

Two distinct, roughly triangular debris deposits occupy much of the lower part of the slide. The remainder of the slide area has a thin debris cover and supports grass, crown vetch, and a few maple saplings (Figure 65). The larger debris deposits are unvegetated except at their edges. The debris consists of flaggy, gray to gray-brown sandstone fragments (up to 4 feet long and 1 foot thick and having an average size of about 8 inches by 10 inches by 2 inches) in a red-brown matrix of sand, silt, clay, and small rock fragments and a few roots, logs, and branches.

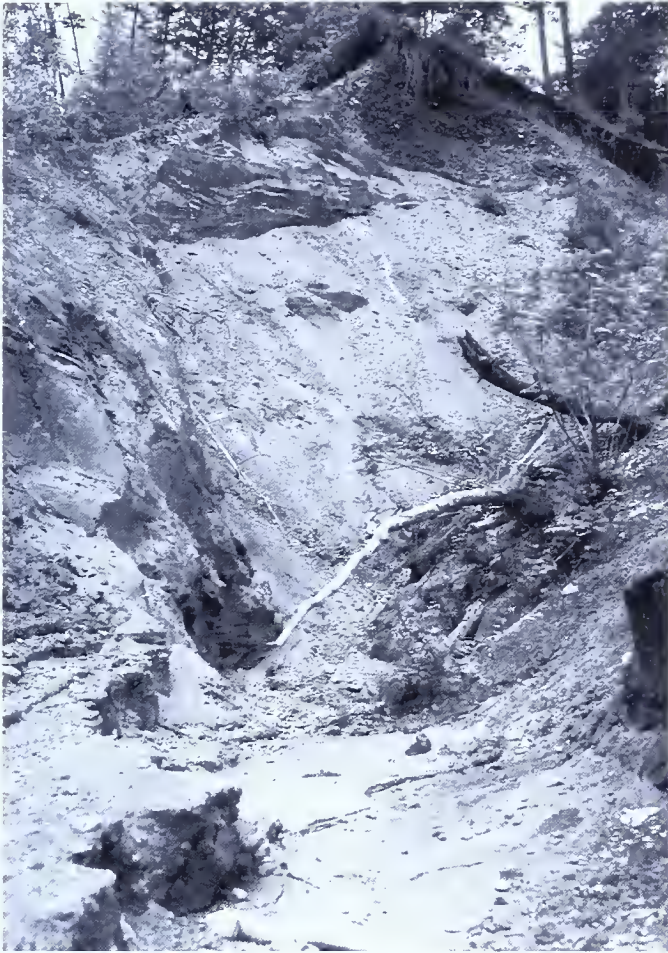
Figure 68. The head-scarp area of the Hunlock Creek debris flow showing glaciofluvial sand and gravel in the upper section. The upper part of the debris fan and incised channel are visible in the foreground.

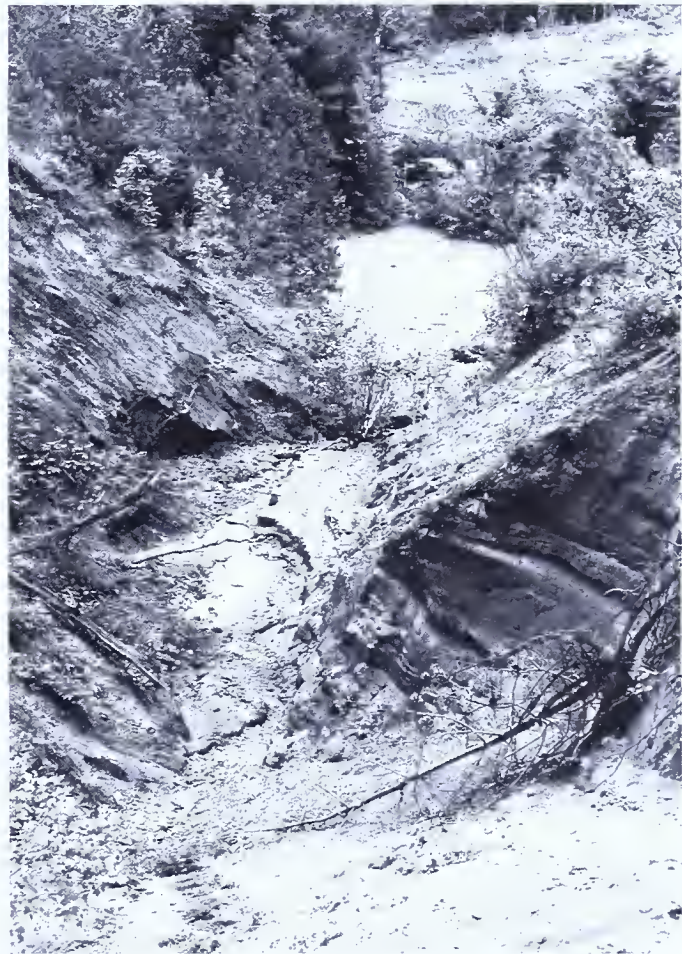
Figure 69. View down from the head scarp across the gully and debris fan of the Hunlock Creek debris flow.

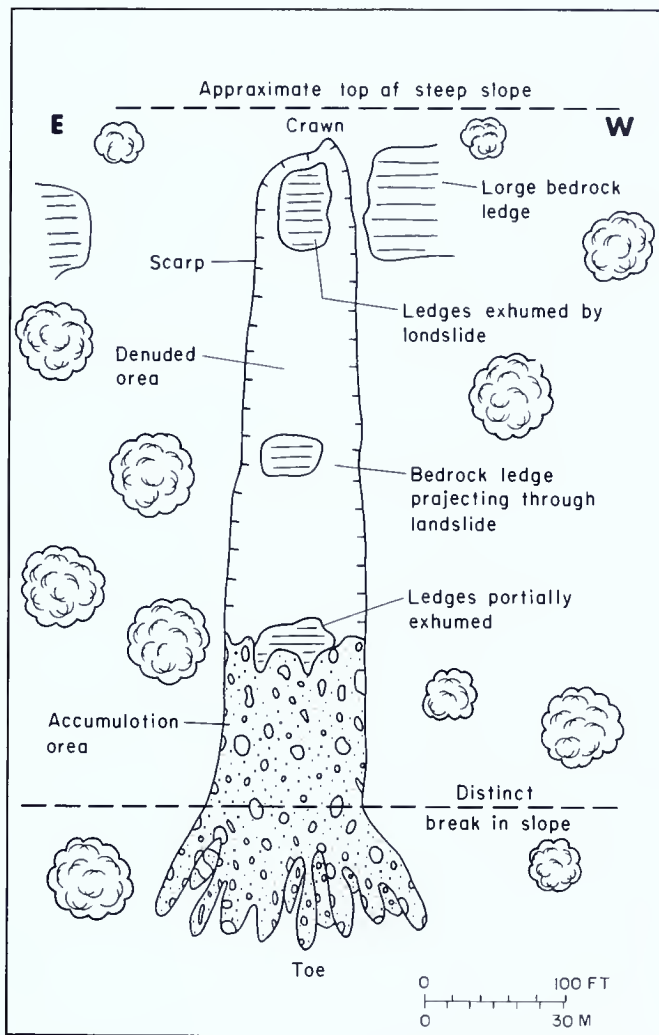
Figure 72. Sketch map of the Nescopeck debris avalanche (from Inners and Wilshusen, 1983, p. 13).

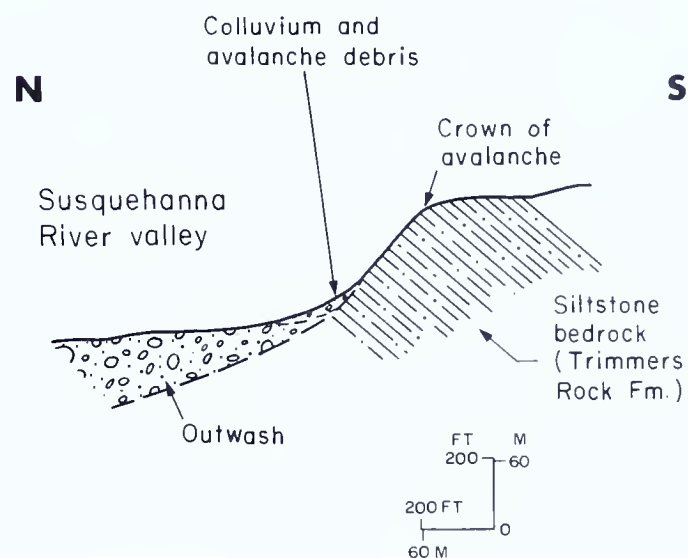
Figure 73. Cross section of the Nescopeck debris avalanche.

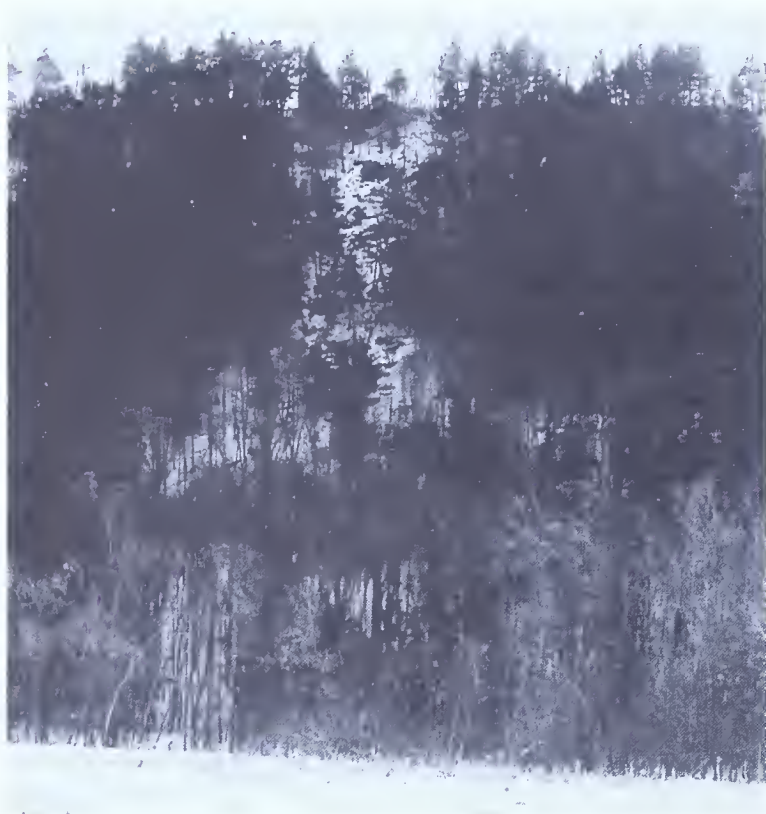
Figure 74. Photograph of the Nescopeck debris avalanche from below.

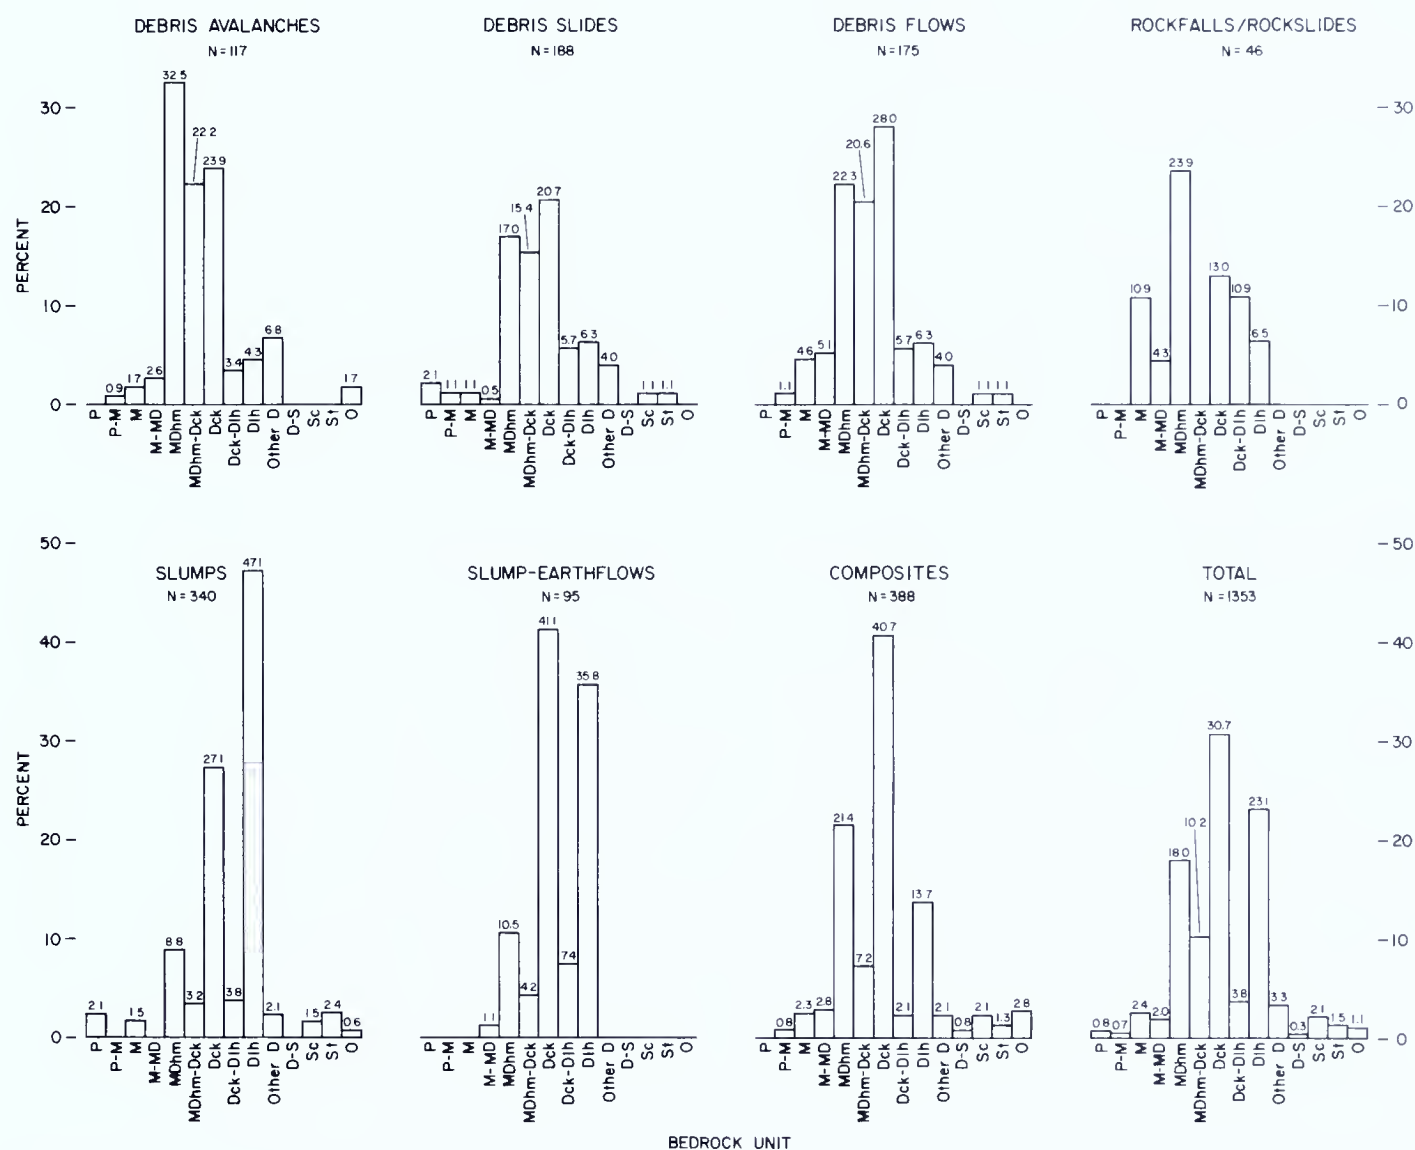
Figure 76. Frequency distribution of landslides by bedrock geology for each landslide type. Some bedrock units from Berg and others (1980) and Table 3 are grouped for ease of handling. P, Pennsylvanian-age sandstones—Llewellyn and Pottsville Formations; P-M, rocks near the Pennsylvanian/Mississippian transition, mostly sandstone and minor shale; M, Mississippian—Mauch Chunk Formation, Burgoon Sandstone, and Pocono Formation; M-MD, rocks near the contact between the Burgoon Sandstone and the Huntley Mountain Formation or Rockwell Formation; MDhm, Huntley Mountain Formation; MDhm-Dck, rocks spanning the transition between the Huntley Mountain and Catskill Formations; Dck, Catskill Formation; Dck-Dlh, rocks spanning the contact between the Catskill and Lock Haven Formations; Dlh, Lock Haven Formation; other D, other Devonian-age rocks, mostly siltstone and shale; D-S, rocks spanning the Devonian-Silurian transition, mostly limestones and shales; Sc, Clinton Group and its upper and lower transition zones; St, Tuscarora Formation; O, various units of Ordovician age.

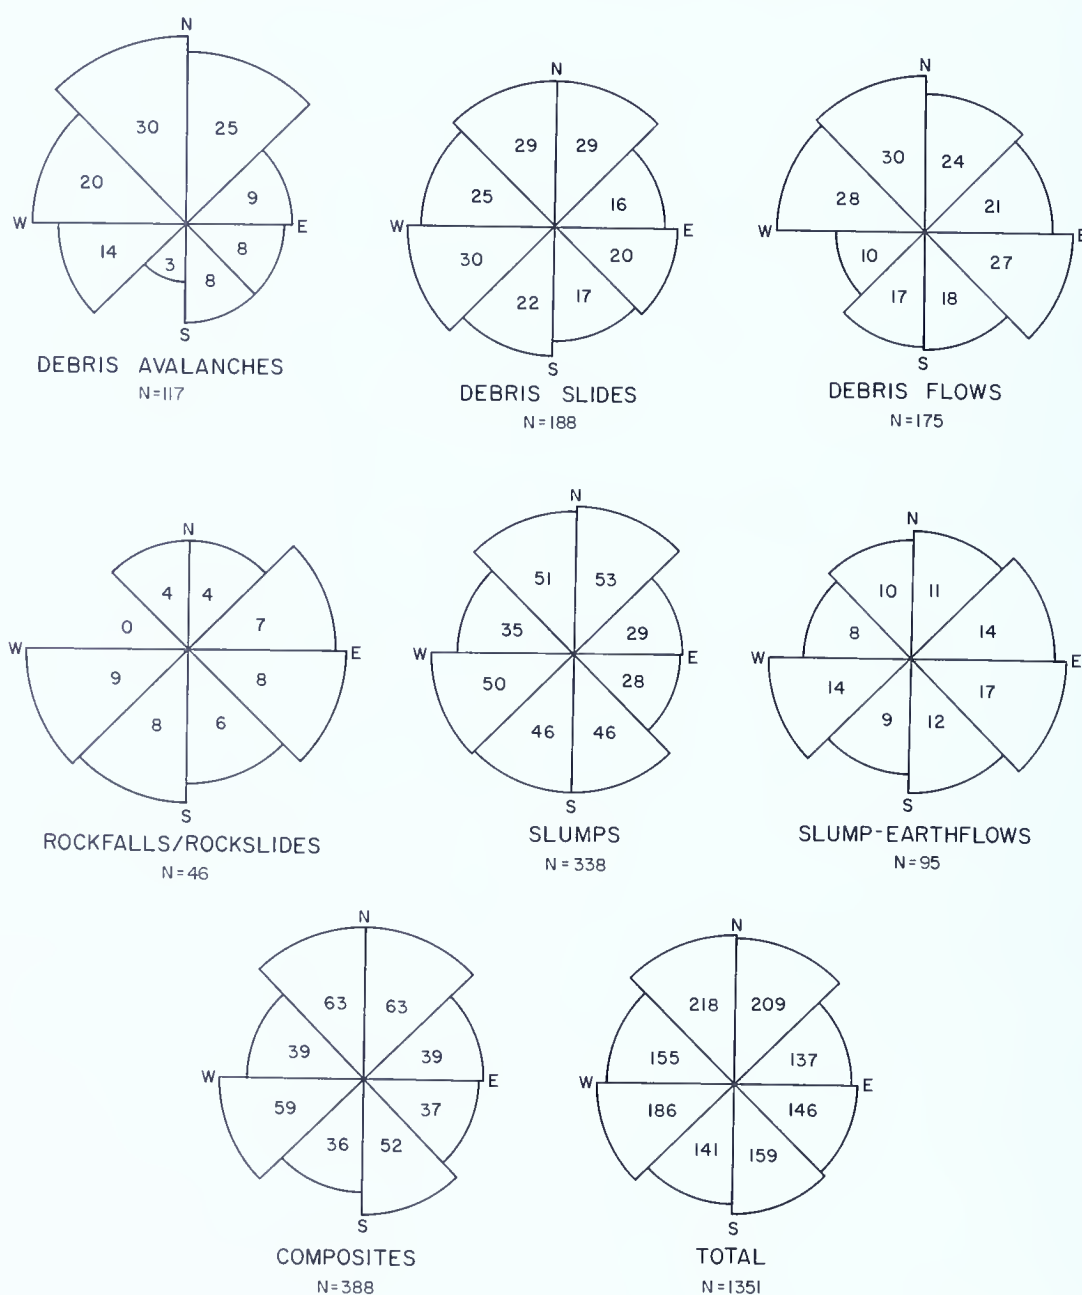
Figure 80. Frequency distribution of landslides by slope azimuth for each landslide type. The area of each segment, not its radius, is proportional to the number of slides.

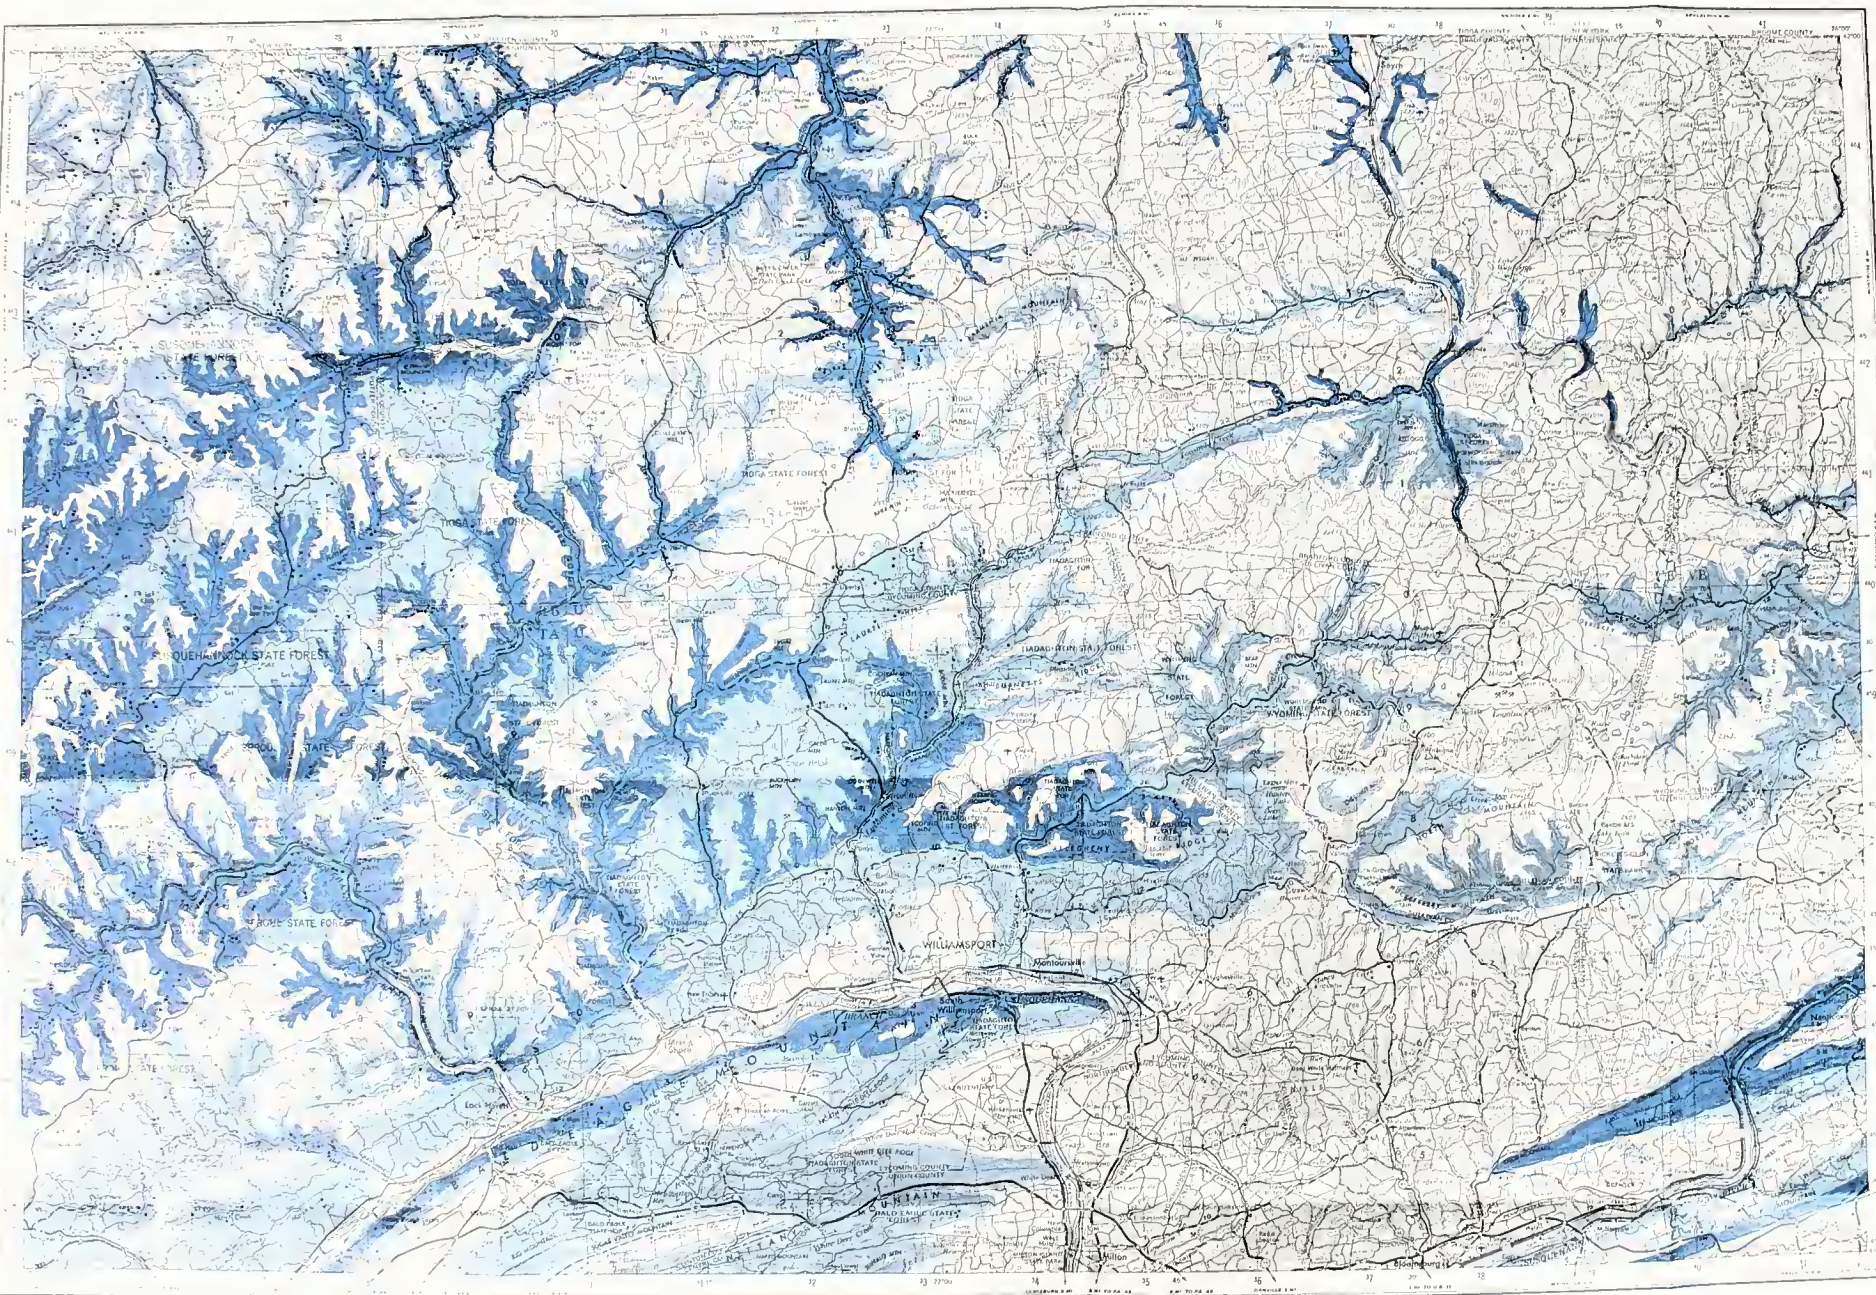
HIGH-SUSCEPTIBILITY ZONE

This zone is highly susceptible to landslide occurrence. It includes areas of high landslide frequency and areas where geologic and topographic conditions are likely to lead to landslide occurrence. Prior to construction in these areas, site-specific terrain investigations should be undertaken to determine potential slope instability. Design for construction should incorporate appropriate engineering procedures to avoid damage from landslides. See text for descriptions of specific areas within this zone that represent local landslide hazards.

This zone is moderately susceptible to landslide occurrence. It includes areas of some landslide occurrence and areas where geologic and topographic conditions may lead to landslide occurrence. Prior to construction in these areas, site-specific terrain investigations should be undertaken to determine potential slope instability. Design for construction may require engineering procedures to avoid damage from landslides. See text for descriptions of specific areas within this zone that represent local landslide hazards.

This zone is least susceptible to landslide occurrence. It includes areas where landslide activity is unlikely except during times of heavy precipitation or after alteration of surface conditions by construction. Prior to construction in these areas, site-specific terrain investigations to determine potential slope instability are generally unnecessary.
